Rotorflush RF200R Testimonial – Trility

Rotorflush RF200R Self-Cleaning Intake Screens. Testimonial from Trility.

Rotorflush RF200R trial, March 2016 Redcliffe Sewage Treatment Plant, Queensland

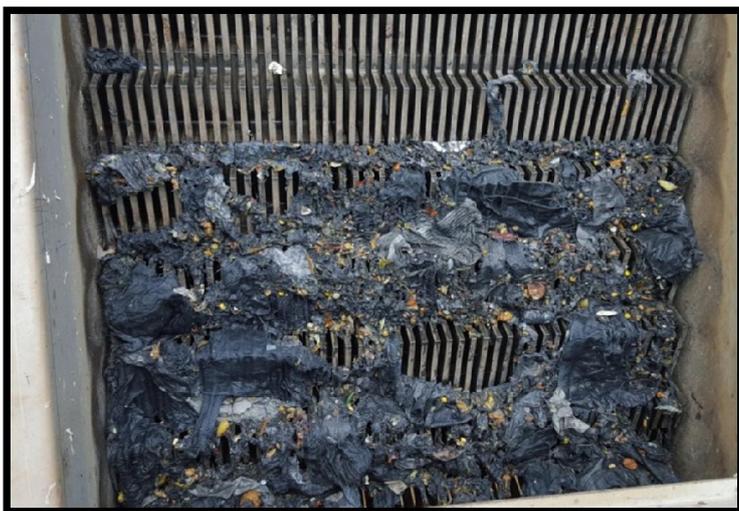
Figure 1 Inlet step screen at Redcliffe STP

A containerised project on the Redcliffe STP required a feed of 30m³/d of raw sewage, however limitations on site deemed the location for this off take to be prior to the inlet screenings and grit removal. Screening of wastewater is vital to remove debris, rag and other solids that end up in the sewage network to protect mechanical equipment and reduce blockages. As shown in the image below, the amount of debris removed from the raw influent is significant; hence pumping upstream of this would require some form mechanical protection.

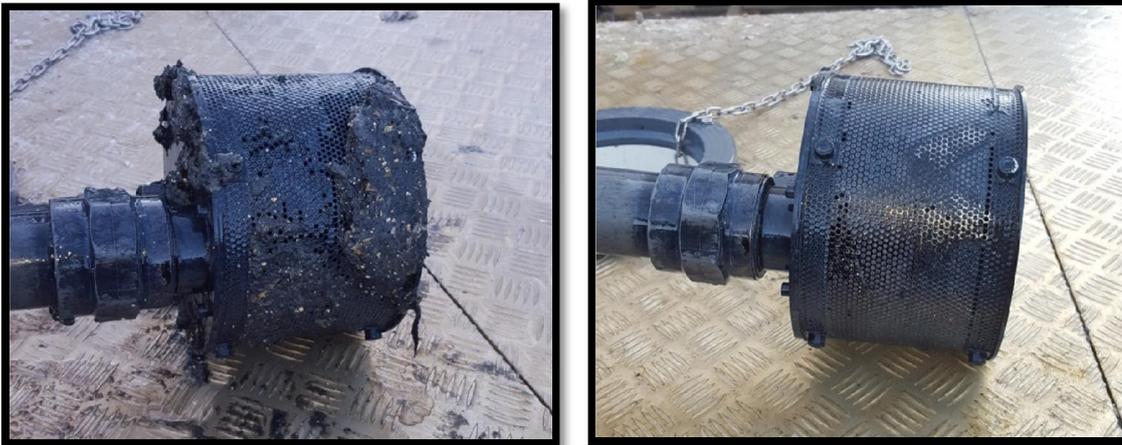
Figure 2 : Rotorflush RF200R straight from service (L) and after low pressure wash down (R)

A Rotorflush RF200R self-cleaning inlet screen was installed on the intake of the feed pump to test the performance of the screen in a raw sewage application. Over the two month trial period the screen operated successfully with no blockages or interruptions in flow. The screen was checked and washed down daily during the first month, reducing to every second day in the second month. Upon removing the screen from service some debris and fibres can be observed, as shown in the photo below, the accumulation of this material is mainly due to the extruding bolts and nuts which create a catch point for fibres and debris, but are easily removed with a low pressure wash down.

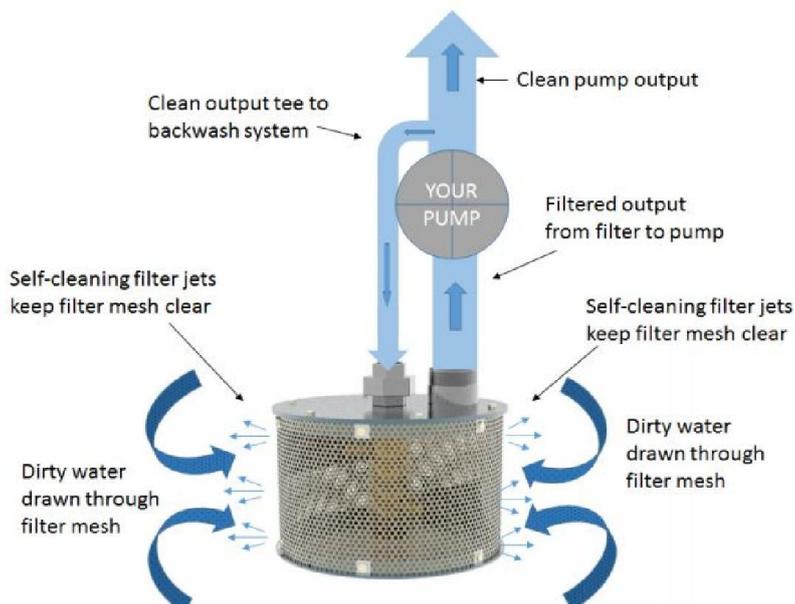
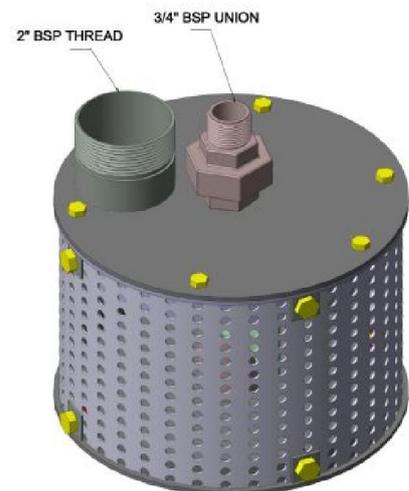
How the RF200R works
